# **Inspection Report**

123 Sample Inspection Street, Jacksonville, Florida 32207

Inspection Date
 June 19, 2019

**Southern Brothers Inspections**

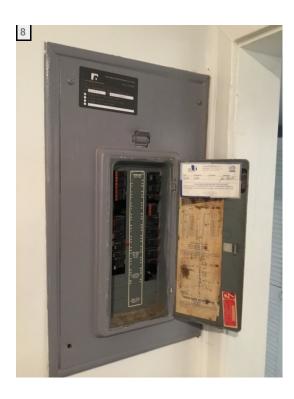
Electric Service Panel	Electric Service Panel	
Safety Concern		
A Federal Pacifi	c electrical panel/component	
Location	Kitchen	
Impact	These panels/components are not accepted by a majority of insurance companies and are prone to failure/overheating	
Suggested Action	Simply replacing the circuit breakers is not a reliable repair. All related components should be replaced by a licensed electrician	
Other Information	Federal Pacific Electrical panels have been the subject of class action lawsuits because their circuit breakers have been known to fail to trip at a higher rate than standard panels. When a breaker fails to trip, an extreme amount of power from the outside electrical supply surges into a the buildings other panels and circuits. Once that happens, it cannot be stopped or shut off manually. Electricity will burn until it runs out of fuel or the wires melt. Many Federal Pacific Electric panels and breakers can operate properly for years, but they can malfunction unexpectedly

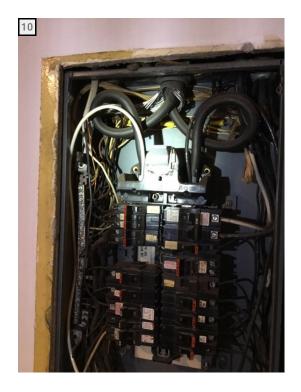
#### Main breaker is double tapped

Suggested Action Other Information Kitchen The main breaker is double tapped, in most manufacturer specifications each lug is designed for one connection. Have repaired or replaced by a licensed electrician as needed Although the double tap is for a lightning protection device, recommend having a licensed electrician further evaluate this condition.

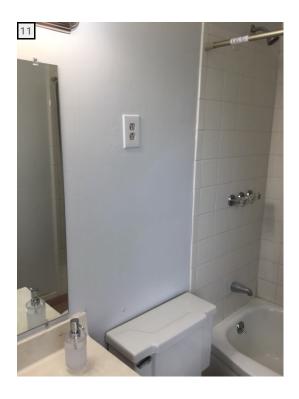
#### Not present within three feet of water source

Location	
Impact	Without a GFCI, there is no mechanism to prevent an electrical short
Suggested Action	Upgrade all receptacle to GFCI protection within 6 feet of all potential wet
	locations
Other Information	GFCI receptacles may be installed, but if the outlet is not grounded the GFCI will not operate as intended.

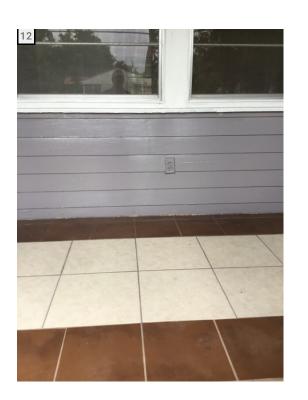
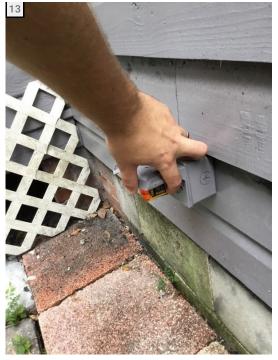
#### Not present at exterior receptacle(s), multiple locations

Impact Without a GFCI, there is no mechanism to prevent an electrical short Suggested Action Upgrade all receptacle to GFCI protection within 6 feet of all potential wet locations, including the exterior

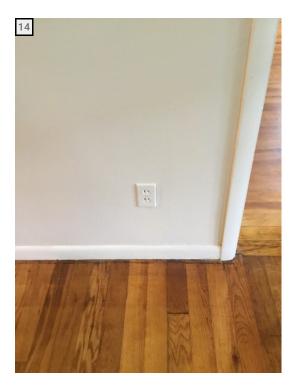
#### Non-grounded outlet style, multiple locations

Location<br/>ImpactGeneral InteriorSuggested Action<br/>Other InformationUngrounded outlets pose potential safety risks<br/>Utilize a licensed electrician to repair/replace<br/>Two prong outlets often indicate the potential presence of outdated wiring.

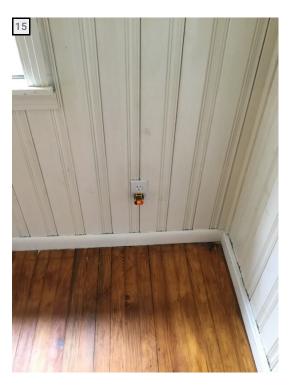
#### Tester shows open ground, multiple locations

**Impact** An open ground outlet can cause an electrical surge to the appliance resulting in damage or electrical shock Have repaired by a licensed electrician

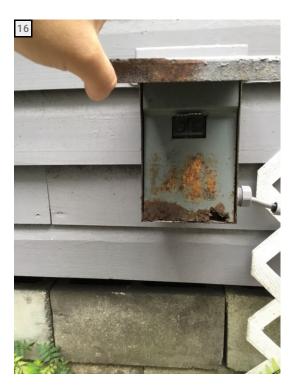
#### A Federal Pacific Electrical panel/component

Location Impact
 Suggested Action
 Other Information
 Exterior
 The panel could overheat and catch fire
 Simply replacing the circuit breakers/components is not a reliable repair. The panel should be replaced by a licensed electrician
 Federal Pacific Electrical panels have been the subject of class action lawsuits because their circuit breakers have been known to fail to trip at a higher rate than standard panels. When a breaker fails to trip, an extreme amount of power from the outside electrical supply surges into the panel and circuits. Once that happens, it cannot be stopped or shut off manually. Electricity will burn until it runs out of fuel or the wires melt. Many Federal Pacific Electric panels and breakers can operate properly for years, but they can malfunction unexpectedly

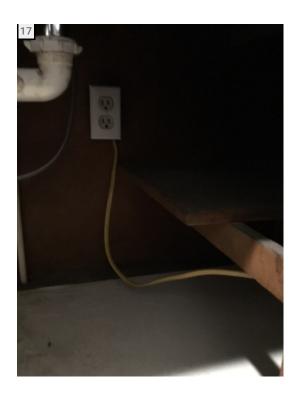
#### **Exposed insulated wiring**

Location	Kitchen
		Exposed wiring should be protected by other means, appropriate conduit or
	impact	
		contained in a junction box or wire nut
S	uggested Action	Utilize a licensed electrician to place the wiring in a junction box with a cover
	55	plate or secure the conduit inside approved wiring conduit (if required),
		following all local building codes.

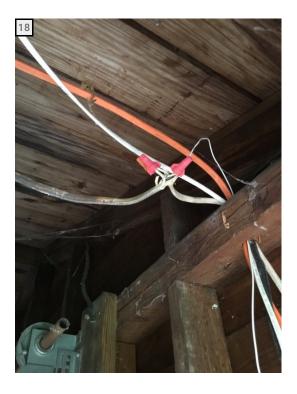
## Exposed, junction box(es) not covered/not installed

Location	Detached Garage
Impact	Exposed wiring can cause electrical shock and lacks containment in the
	event of arching
Suggested Action	Place the wiring in a junction box with a cover plate or secure the conduit
	inside approved wiring sheath
<b>Other Information</b>	Exposed wiring should be capped and in a junction box with a cover plate or
	removed

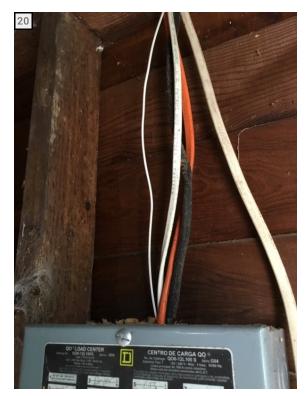
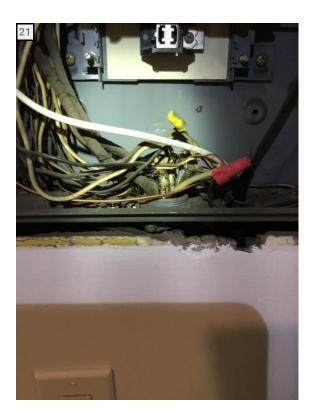
#### **Presence of cloth wiring**

Location<br/>ImpactDetached Garage, Exterior<br/>Cloth wiring is an indication of an outdated electrical system and may<br/>present a safety hazardSuggested ActionUtilize a licensed electrician to update the electrical system, it's<br/>components, equipment, and wiring

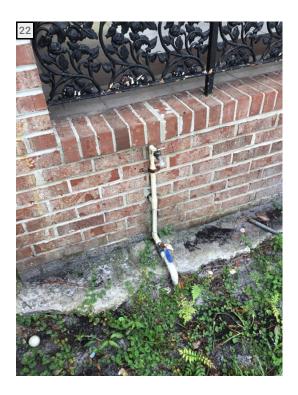
Freeze protection worn/not present, at main water supplyLocation<br/>ImpactExteriorFreezing temperature can damage exposed plumbing pipes, causing<br/>damage to systemSuggested ActionInsulate plumbing exposed to the elements

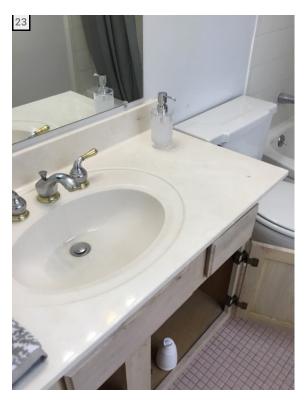
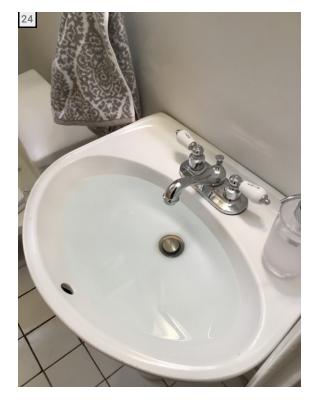
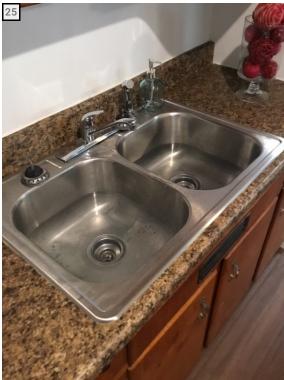
Location<br/>ImpactBathroom, KitchenEffective draining of water, clogged drain linesed ActionClear the drain of debris with a rodder, contact a licensed plumbing<br/>professional if issue persists

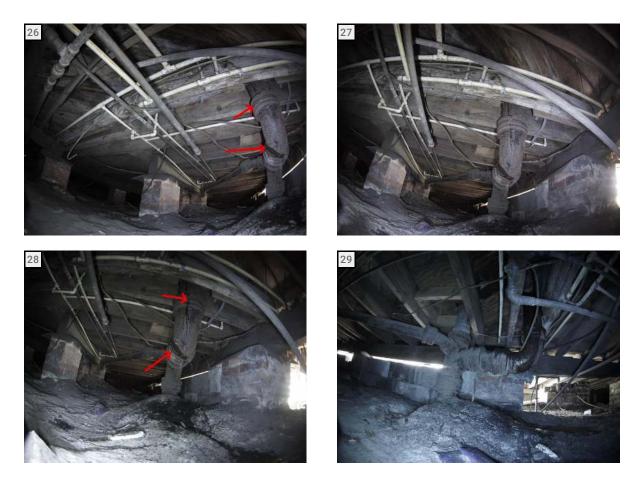
#### Leaking, cast iron waste line failed

LocationCrawl SpaceImpactLeaking water, damage to surrounding areas, proper operation of plumbing<br/>systemSuggested ActionReplace damaged components by a licensed plumbing contractor

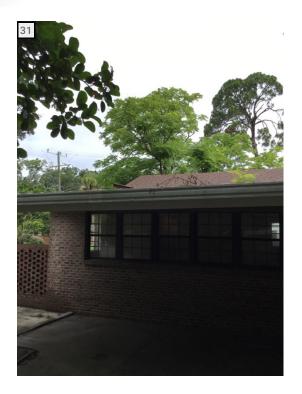
#### Debris on roof surface

LocationExteriorSuggested ActionClear the debris from the roof

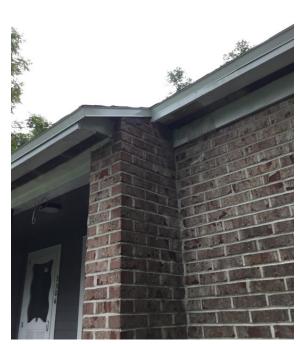
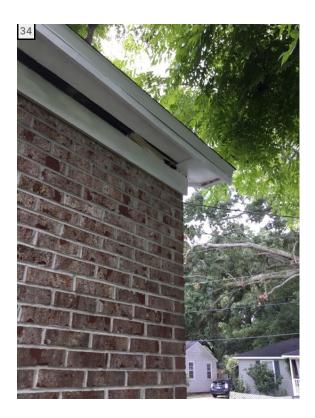
Moderate Concern		
Soffit/Fascia is o	damaged, see photos for examples	
Location	Exterior	
Impact	Damage and evidence of previous repair. Monitor this area for changes or further damage.	
Suggested Action	Replace or repair damaged soffit/fascia. Seal all gaps and transitions with appropriate sealant. Consult with a licensed contractor for complete repair prescription.

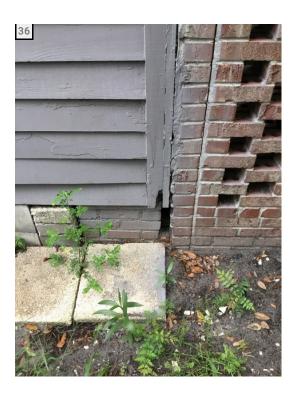
Damaged wood trim component (see photos for examples)		
Location	Exterior	
Impact	Further/ongoing damage due to proximity, locations and compromise of wood surface or exposure to moisture	
Suggested Action	Have condition further evaluated by a licensed contractor for remedy and repair prescription, if desired. Utilize a licensed pest control operator for identification of wood destroying organisms. Repair/replace damaged components

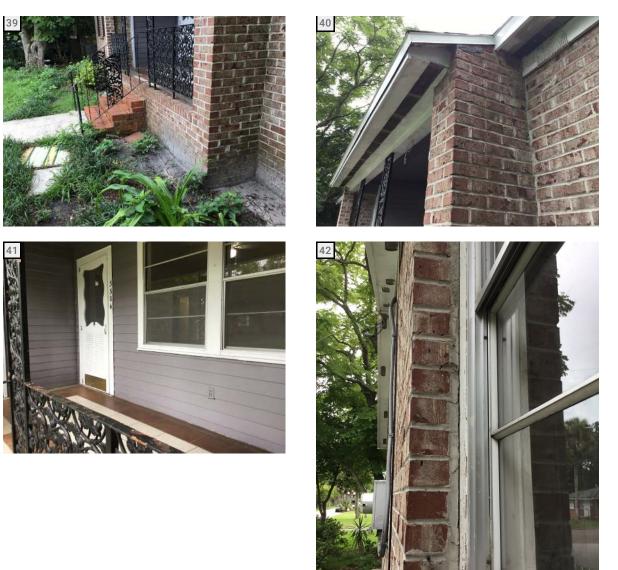
Brick siding currently in place is not original to the house. No permit record indicating permitted work.

Location	Exterior
Impact	Proper installation and engineered design, no ability to confirm tie backs or
Suggested Action	proper installation Workmanship and installation should be further evaluated by a licensed contractor

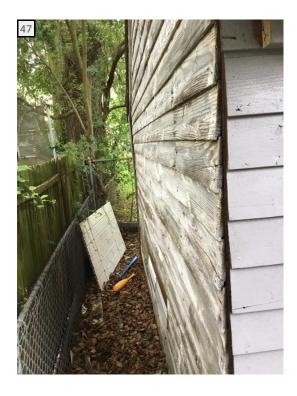
#### Material is damaged (see photos for examples)

**Impact** Damaged siding negatively effects the materials designed intent to eliminate moisture intrusion. Damage to the siding material exposes the system to further/ongoing damage

Repair or replace the damaged area(s). Utilize a licensed pest control company for further evaluation of Wood Destroying Organism specific activity on the structure.

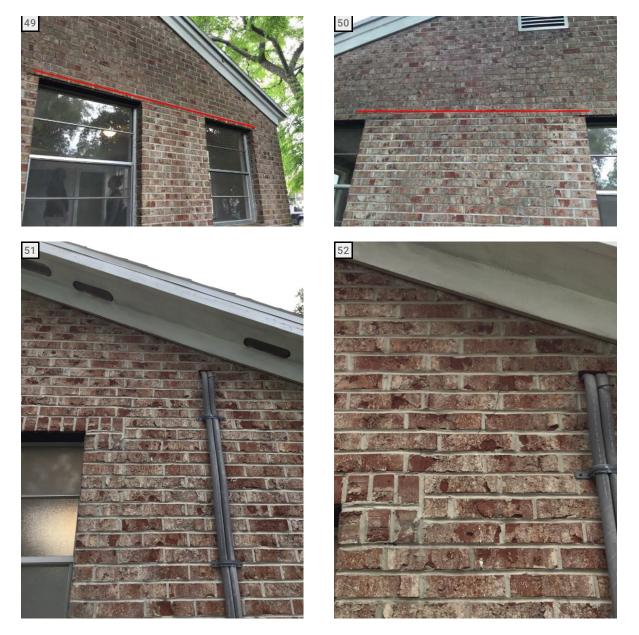
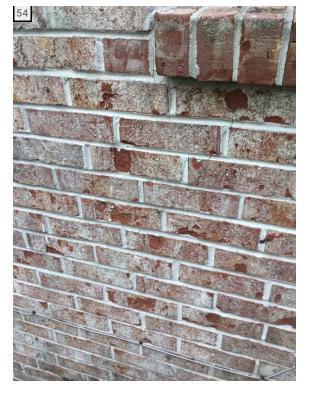
#### Mortar has cracks, voids or is loose

Location	Exterior	
Impact	Moisture intrusion, effective bonding of siding system. Potential for ongoing	
	settling and further damage	
Suggested Action	Utilize a professional mason to repair/replace. Assure complete sealing of	
	corners and joints with appropriate mortar/sealant. Monitor and maintain. If	
	concerns warrant contact a licensed contractor for further evaluation.

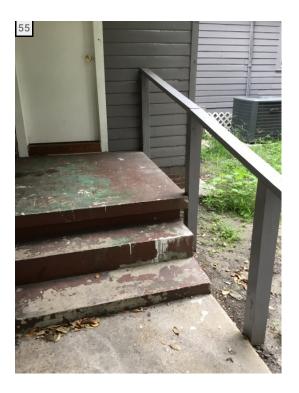
#### Handrail missing graspable hand hold and balusters

Suggested Action Utilize a licensed contractor to install hand holds that are of a graspable nature. Follow all local building codes

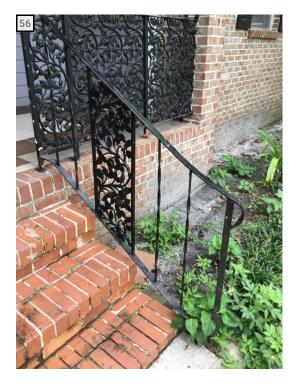
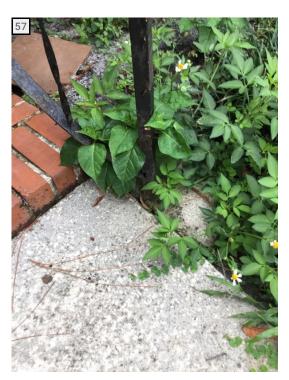
#### Handrail/guardrail is damaged/loose

Exterior Damaged/loose railing reduces the stability and safety of the occupants Repair/replace damaged/loose components of the railing, follow all local building codes for safety and protection of occupants

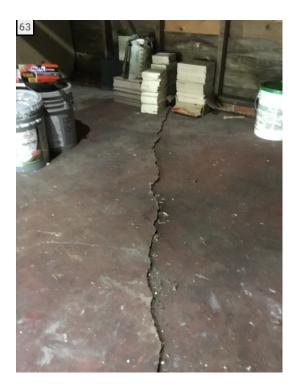
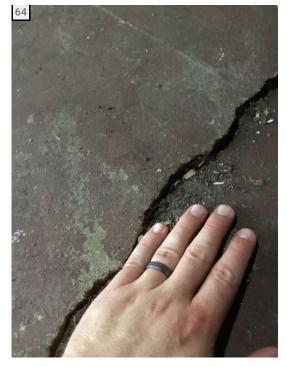
#### **Concrete floor has significant cracking**

Location	Detached Garage
Impact	The size and length of the crack indicate potential settlement
Suggested Action	Monitor the crack and surrounding areas for changes in, or development of,
	size, shape, length, etc. Utilize a licensed structural engineer for further
	evaluation and prescription of repairs/maintenance.
<b>Other Information</b>	Some expansion cracking in concrete slabs is to be expected by nature of
	the material. Monitor for changes in thickness and development of raised
	edges or valleys, indicating significant movement.

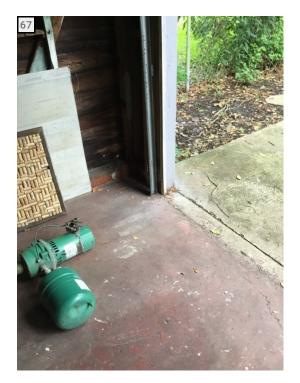
**Location** Detached Garage Impact No safety feature in the event of crossed threshold Install safety reversing sensors. Follow all manufacturer installation instructions.

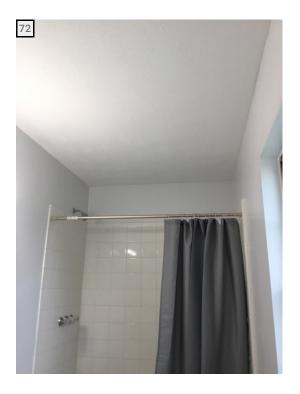
## Missing

Impact Without an exhaust fan, moisture can not be removed Install an exhaust fan would assist in prompt removal of moisture to avoid moisture damage

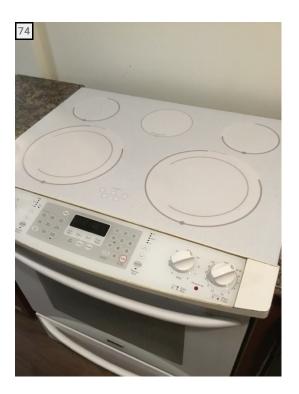
### Anti-tip over bracket is not engaged

Location<br/>ImpactKitchenOven/Range units of this design have a high tip over potential when the oven<br/>door is fully opened, causing a safety concern for young children and<br/>occupants of the kitchen.Suggested ActionInstall oven to fit into anti tipping bracket

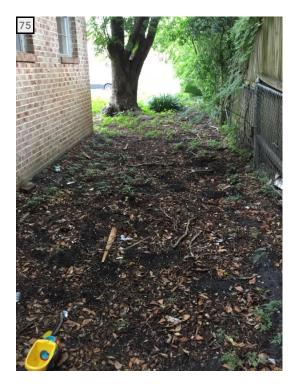
water Exterior Foundation and drainage
Suggested Action	Slope grade away from foundation. Extend gutters and downspouts to discharge four feet away from the foundation where possible
Other Information	Pooling and ponding water are a concern to the structural integrity of the foundation, if this condition has been or remains a long standing issue. In extreme conditions, standing water can reach heights above the foundation and penetrate to other materials, such as framing, exterior sheathing, interior trim, and interior wall coverings, via capillary action (wicking). Furthermore, highly saturated soil leads to a higher risk of insect and termite activity.

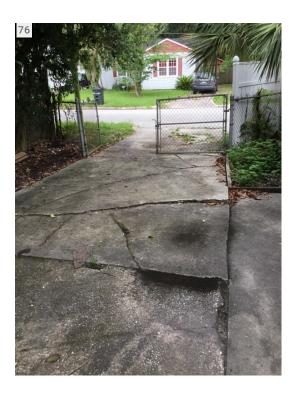
### Concrete is settling/heaving, trip hazard

Location	Exterior
Impact	The cracks allow for water intrusion, which may cause the surrounding surfaces to also deteriorate causing further/ongoing damage overtime.
Suggested Action	Monitor for further development of cracks, increasing in size or number.
Suggested Action	Consider replacement if issues worsen.
Other Information	Changes in elevation and concrete settlement may cause unforeseen tripping hazards.
