# **Inspection Report**

123 Sample Inspection Street, Jacksonville, Florida 32207

Inspection Date
 June 19, 2019

**Southern Brothers Inspections**

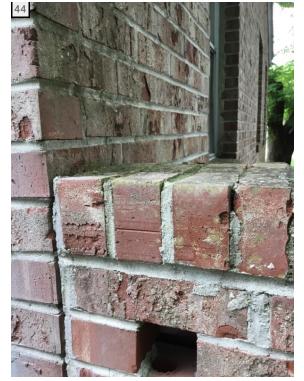
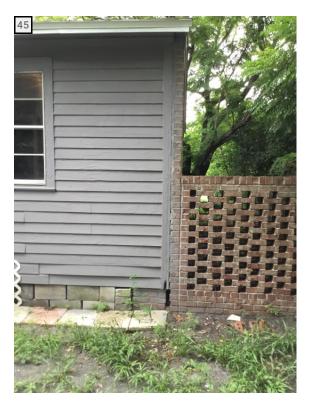
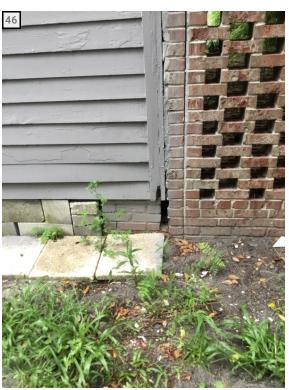
Location Detached Garage

- 34. Siding (Detached Garage): Material is damaged (see photos for examples)
- 35. Siding (Exterior): Mortar has cracks, voids or is loose

#### Material is damaged (see photos for examples)
